# Selling Arguments *for* TIN ROOFING

*A review of the advantages of  
roofs of this type*

A textbook containing corrected tables for use in estimating, instructions for laying tin roofs, description of the manufacture of roofing tin, and a large amount of information useful to the practical man.

N. & G. Taylor Company, Philadelphia

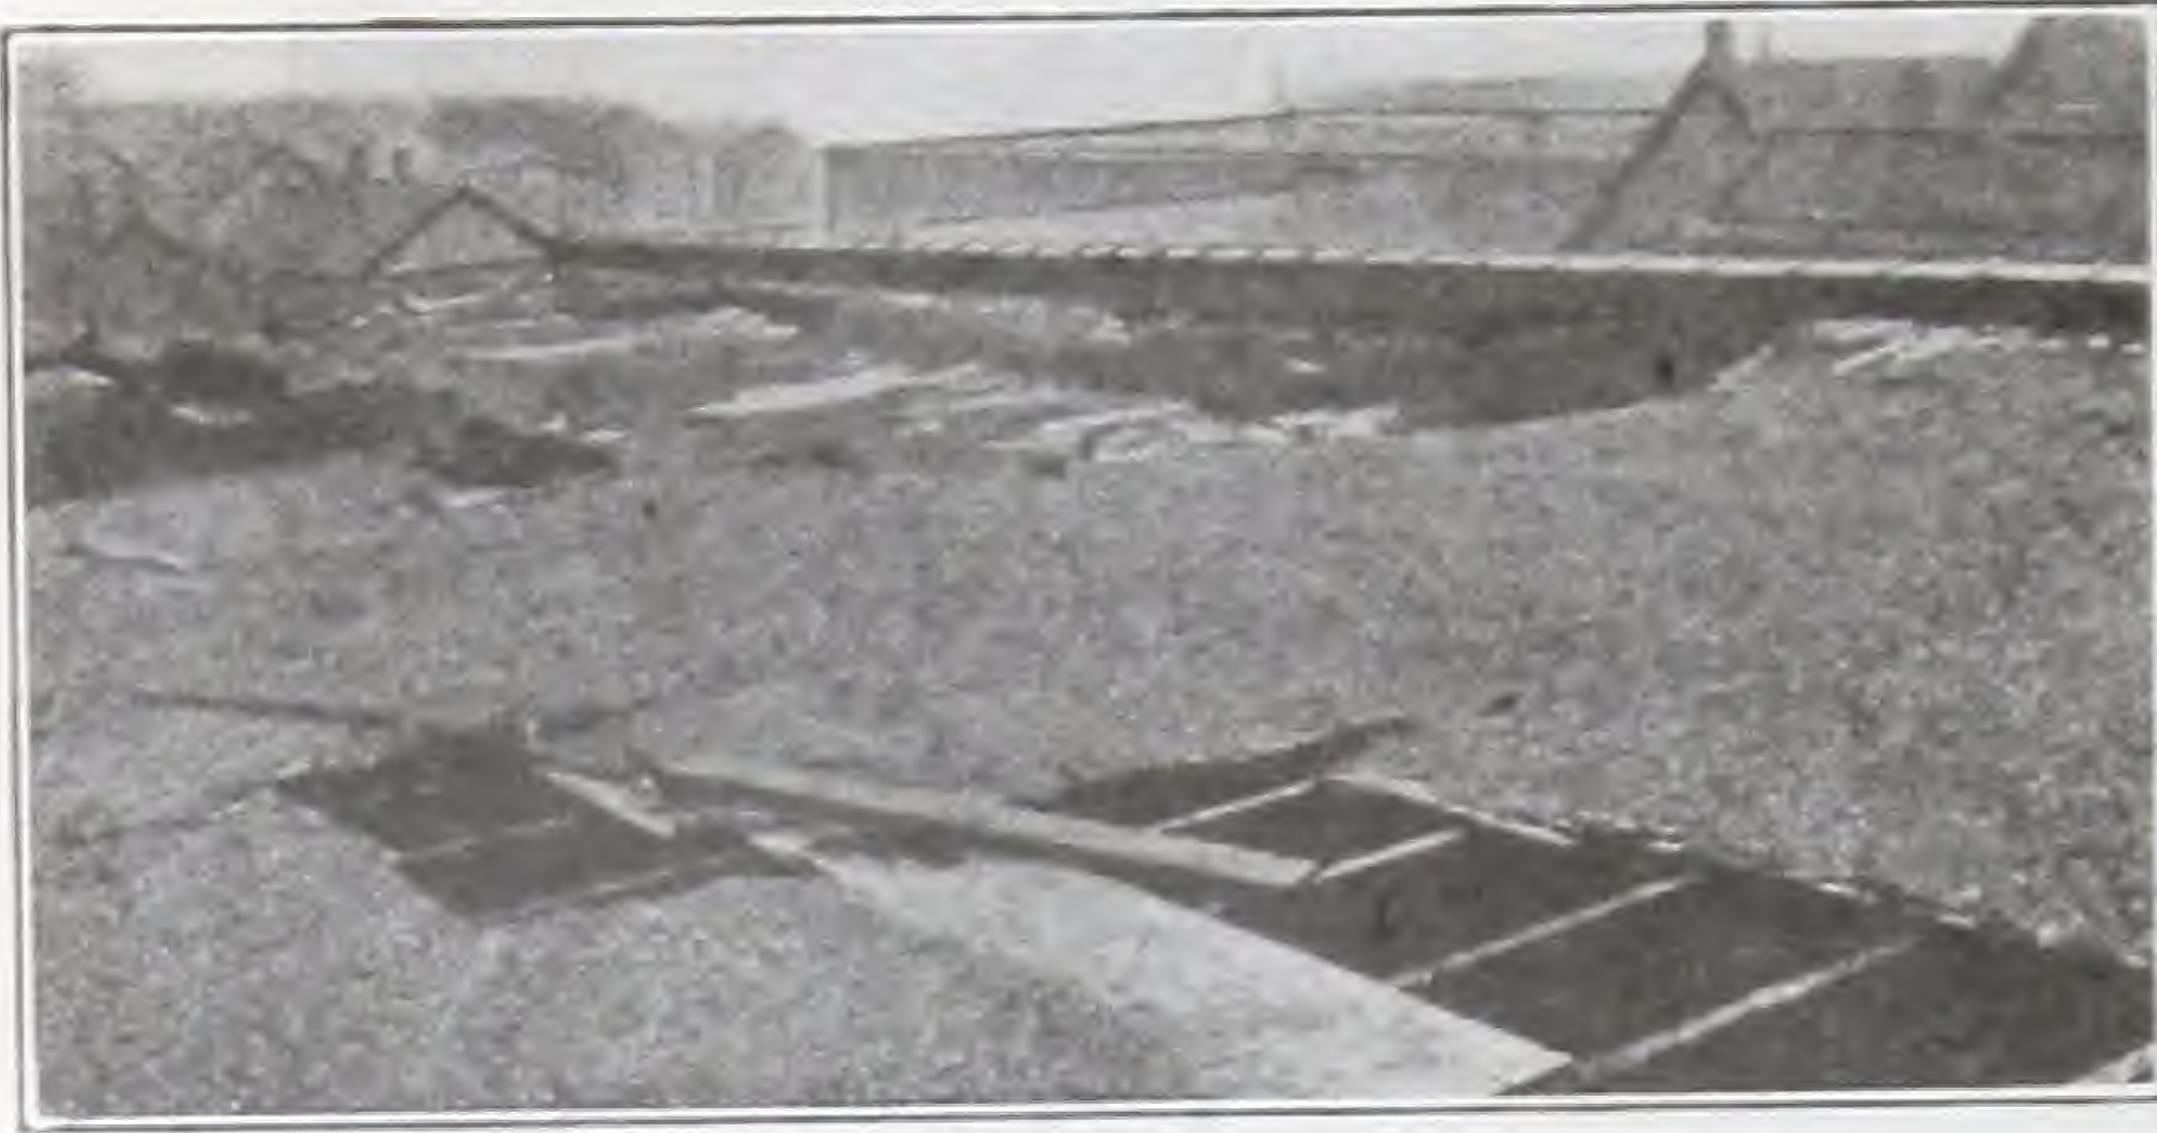
**38. LACK OF FIRE PROTECTION :**

As a contrast to the preceding illustration, note this view of a tar-and-gravel roof after a recent fire. Although the heat has not been sufficient to destroy the supports of this roof, nevertheless it has burned completely through the tar roof in great holes, giving a free upward draft. Much of the tar and gravel has disappeared entirely, having melted away, adding fuel to the flames.

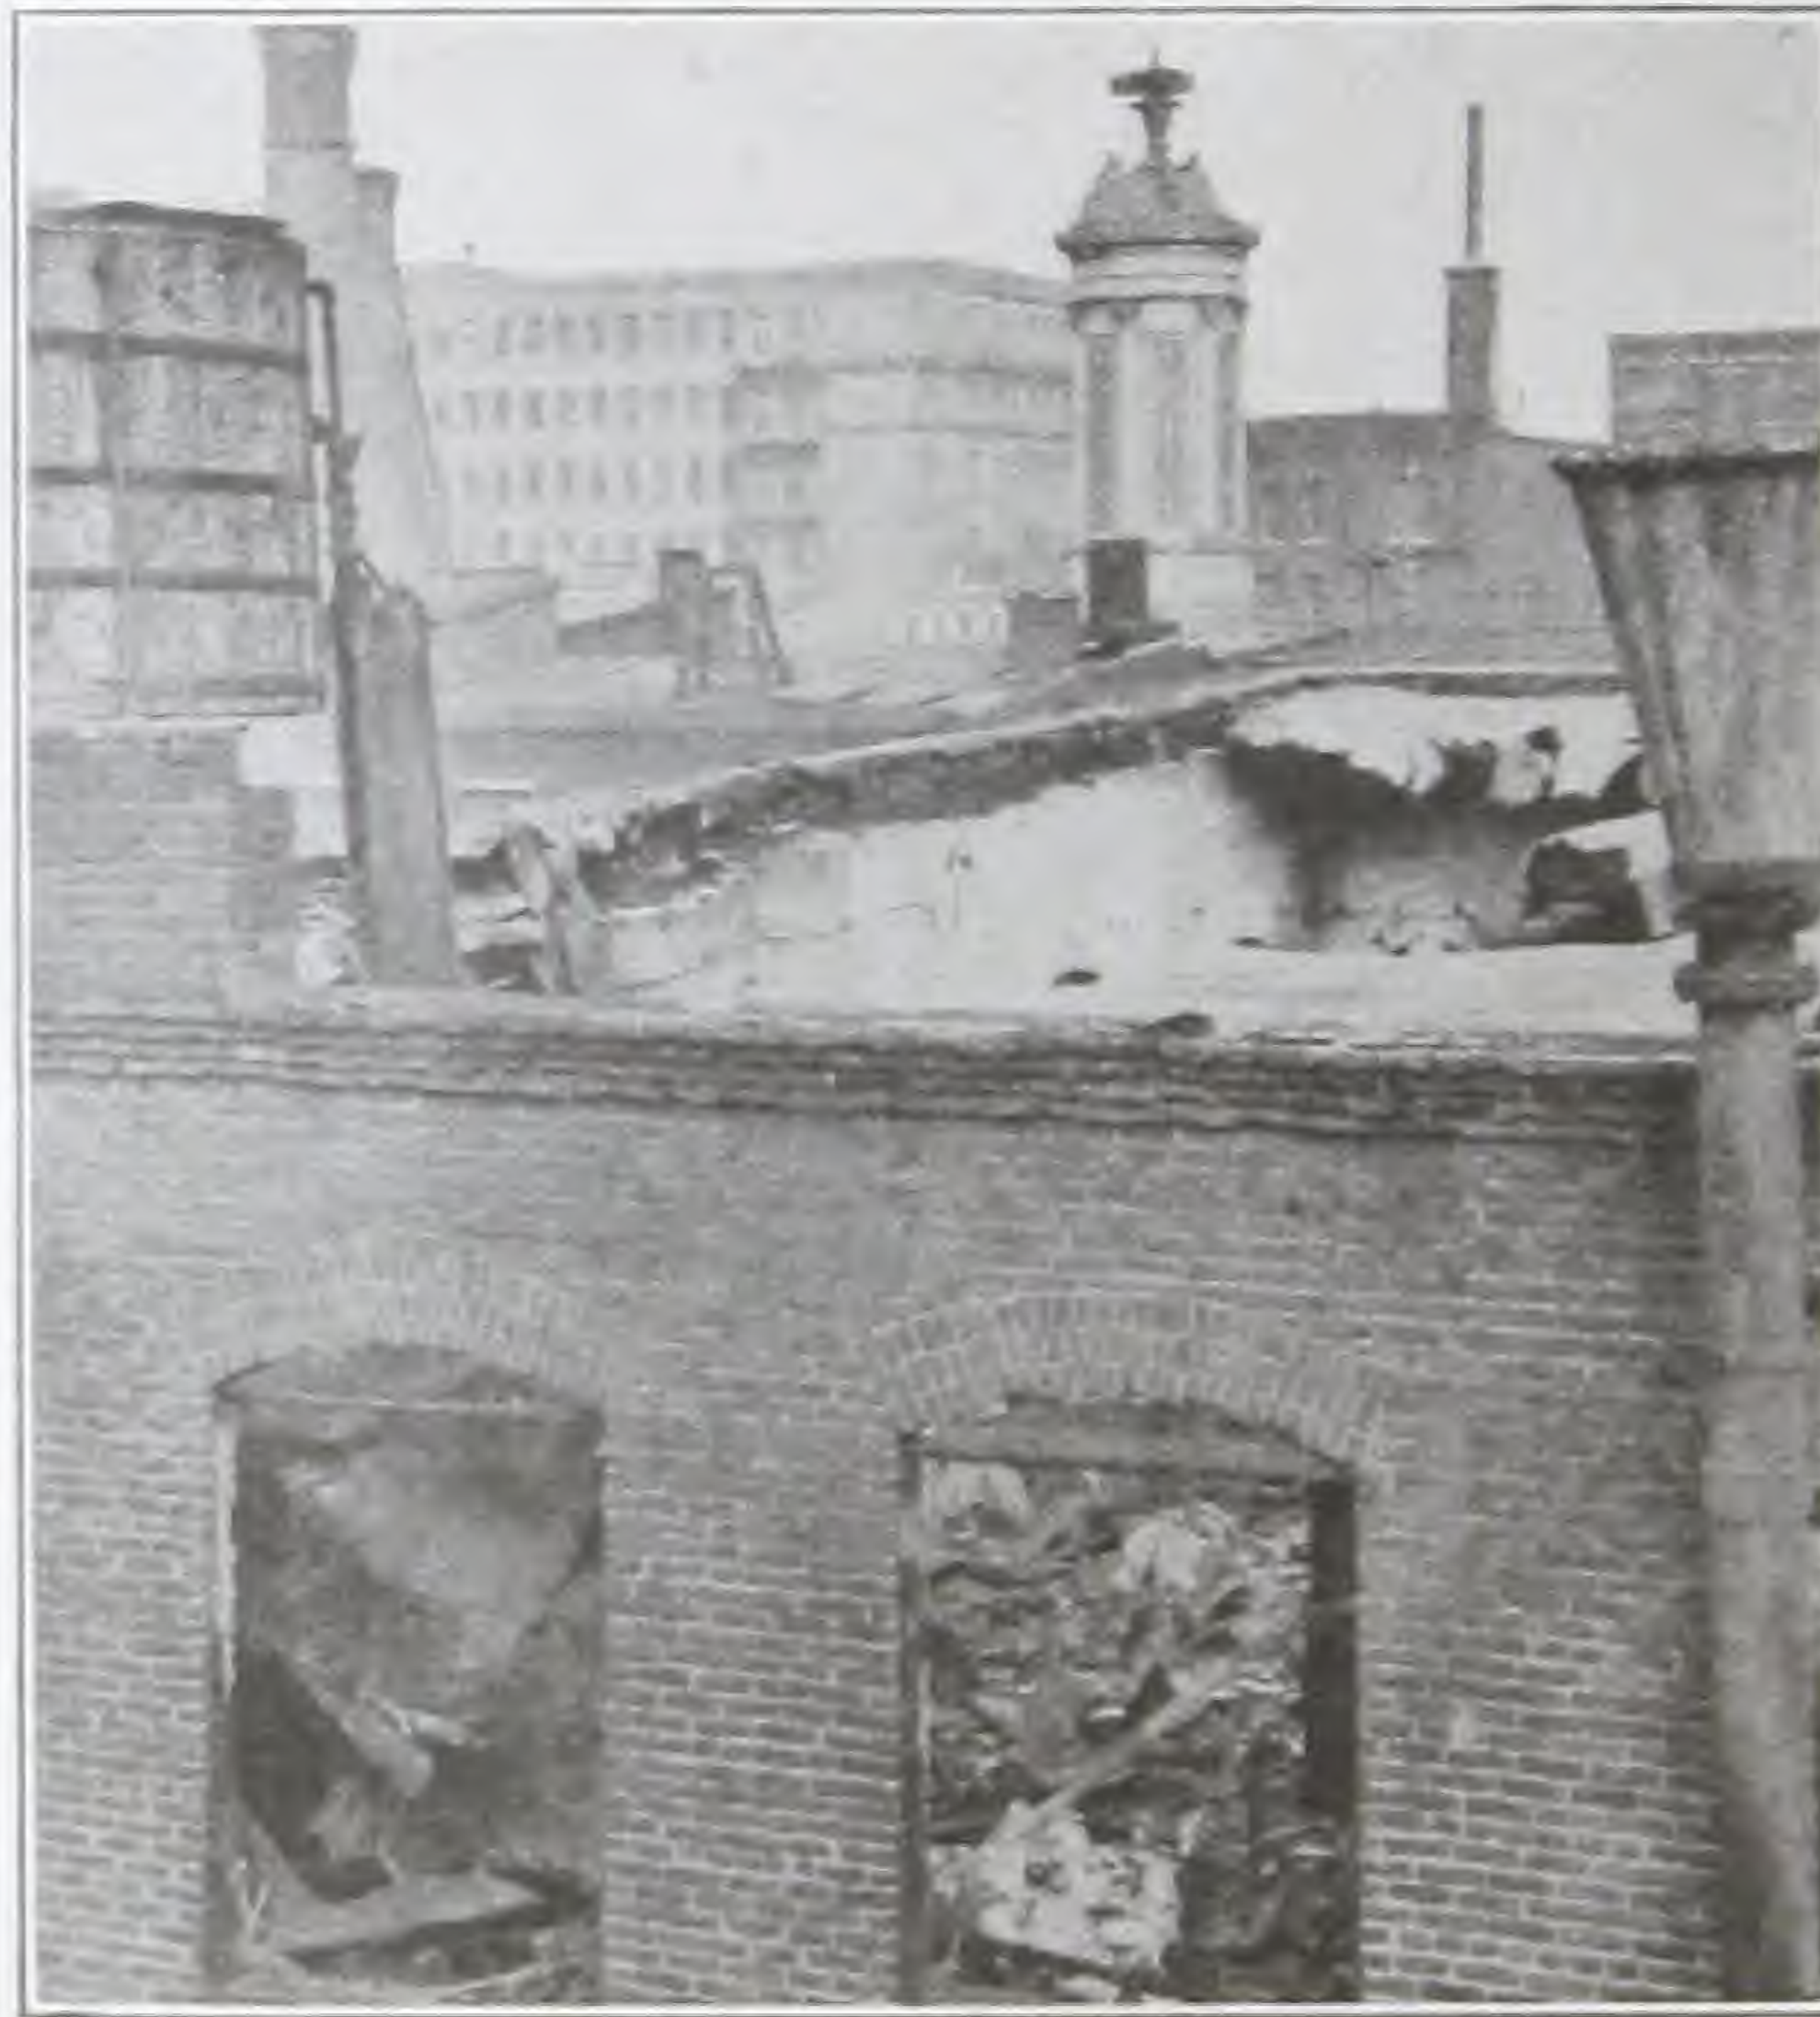
**39. LACK OF FIRE PROTECTION :** In January, 1910, the building at 208 Chancellor Street, Philadelphia, was partly destroyed by fire which started on the top floor, burning through the tar-and-gravel roof, of which it made short work, the burning tar and paper adding to the difficulty of controlling the fire. Thanks to the efficient work of the Philadelphia Fire Department, and in some degree to the tin roofs covering the surrounding buildings, the fire was confined to the upper stories, but not without regrettable loss of life.

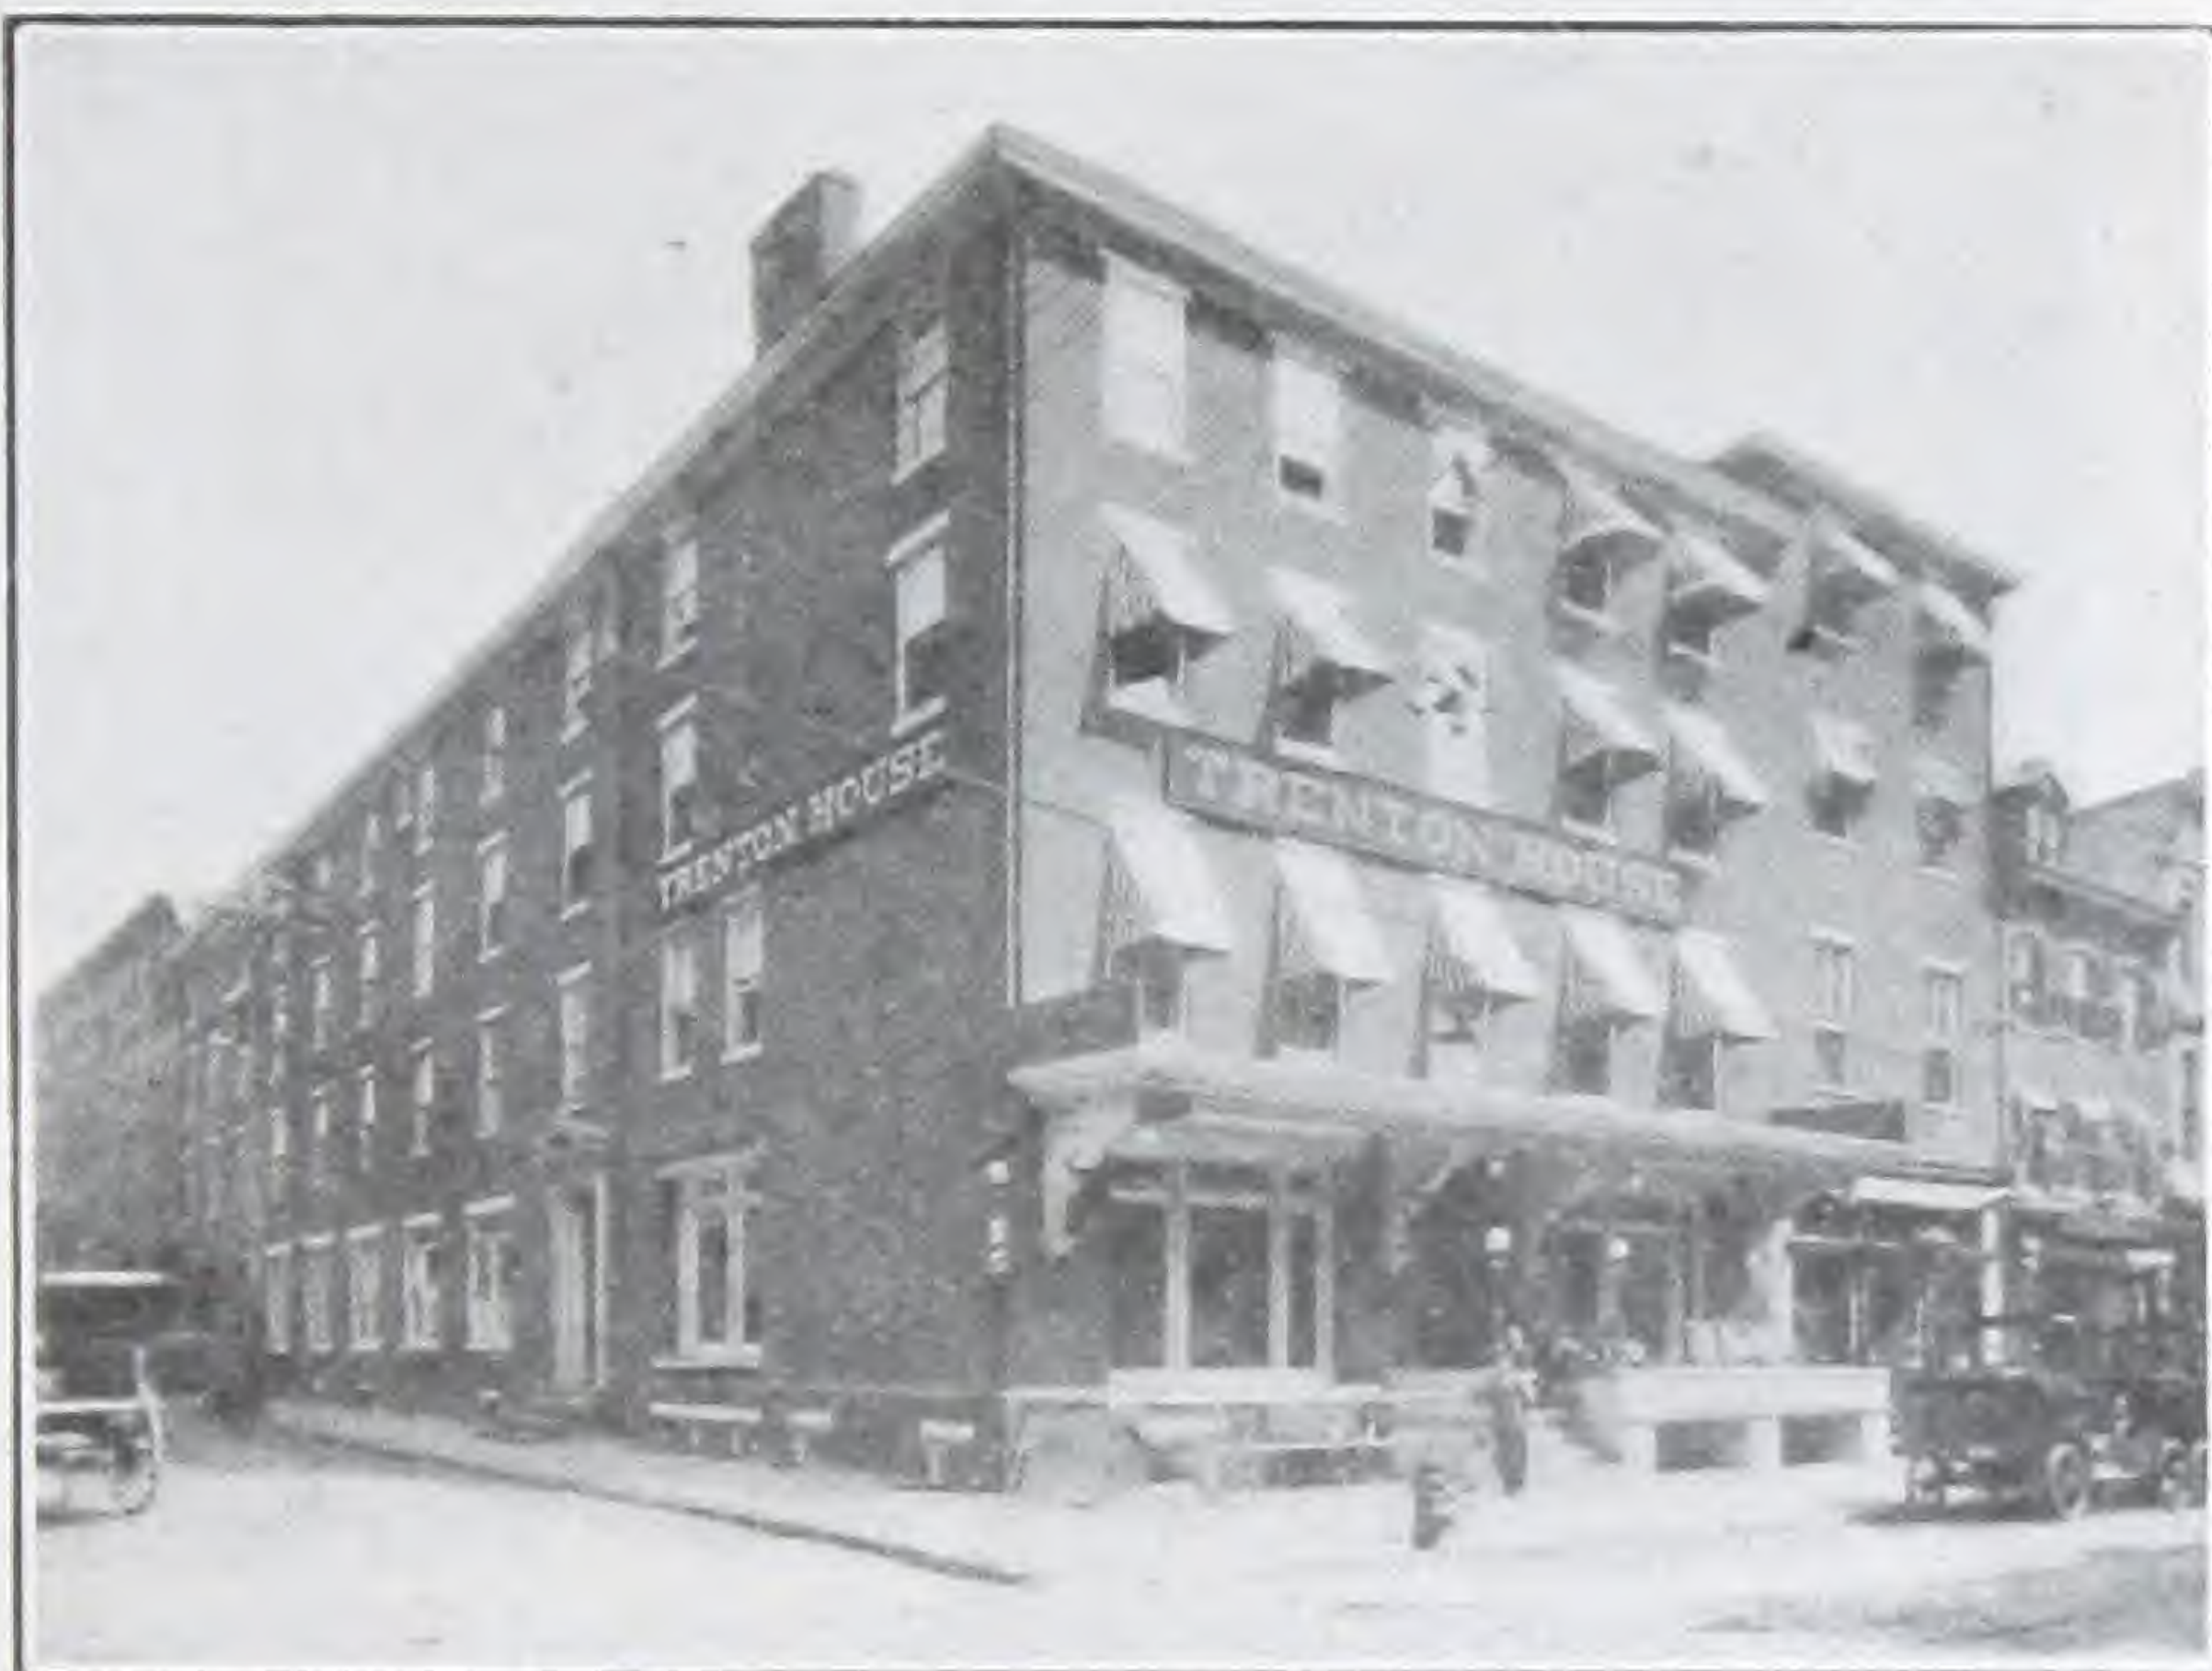
**41. WEATHERPROOF:** The old Trenton House, in Trenton, N. J., is still covered with the tin roof put on in 1809—102 years ago. This roof remains in good condition and has defied all attacks of the weather for more than a century.

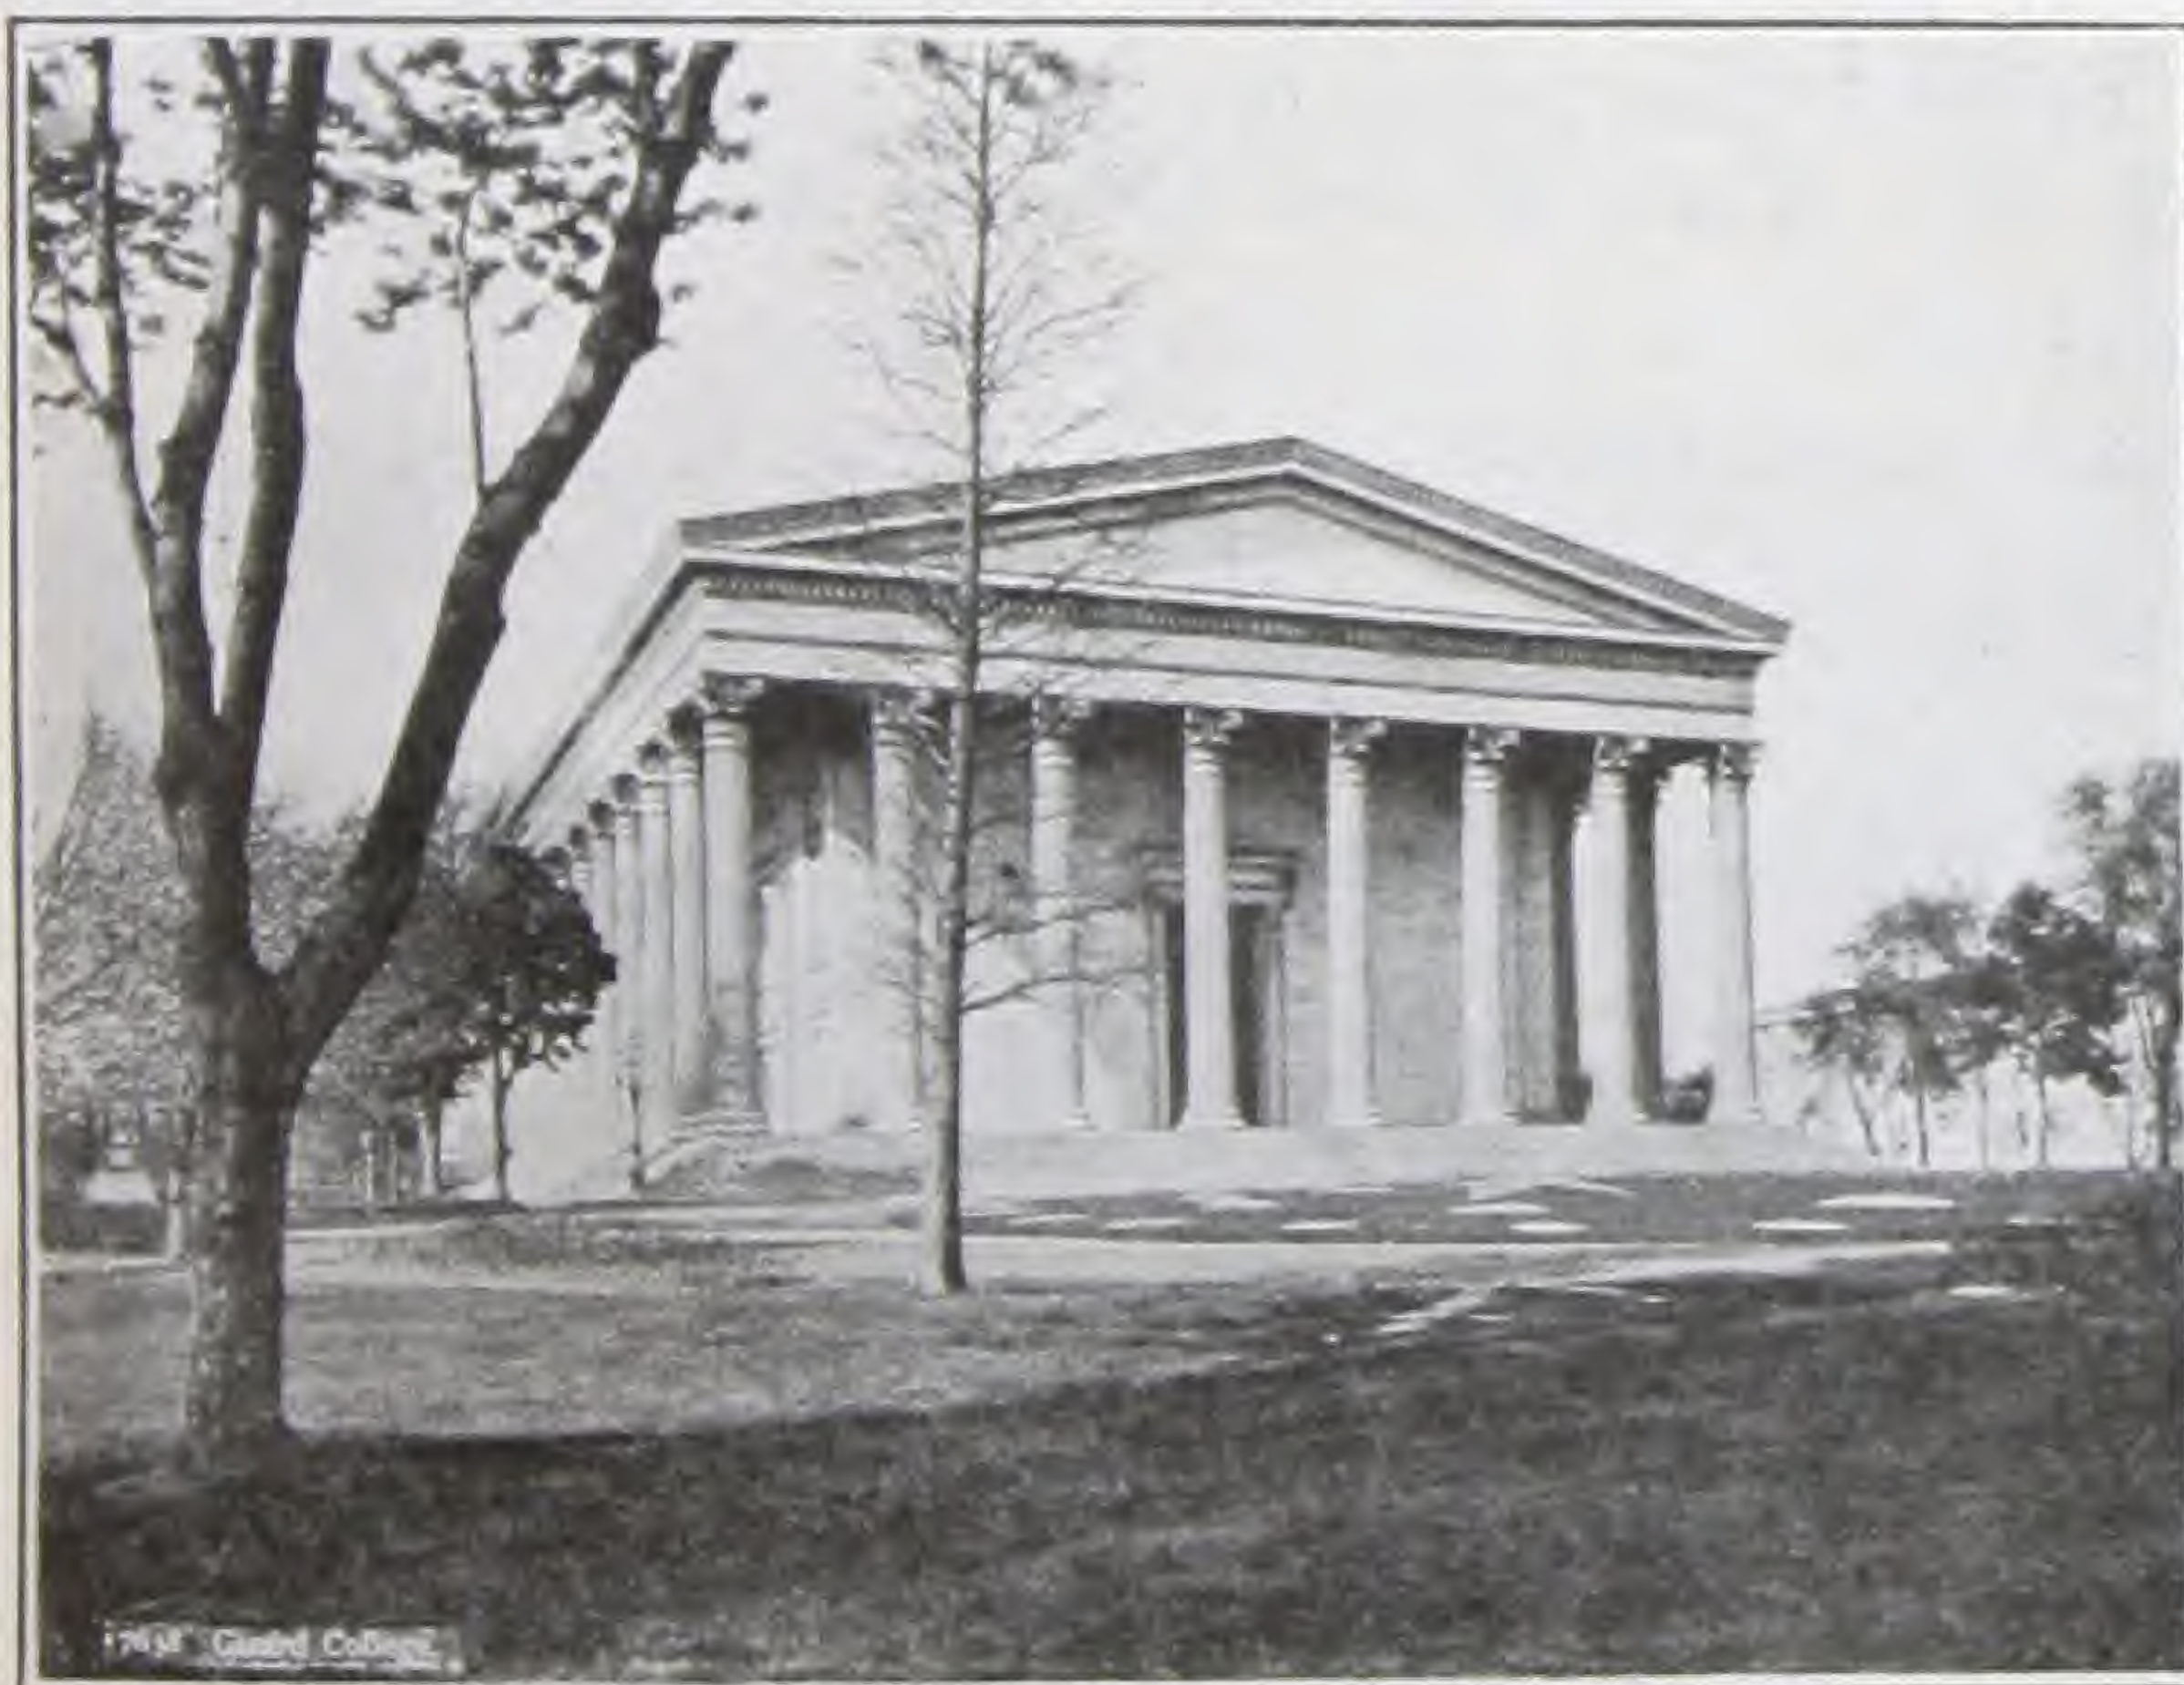
**42. WEATHERPROOF:** The main building of Girard College, in Philadelphia, shown in this illustration, was built in 1830 and roofed with marble slabs from three to four feet square, by four inches thick. These were laid step-fashion, overlapping, and the builders thought they had a roof that would never require any attention. But it proved a source of constant trouble, as the marble disintegrated, the joints worked loose, and leaks developed. Finally, in 1880, the trustees were compelled to consider a new roof, to prevent further damage to the building. The choice was made in favor of good tin. Scantlings were bolted to the marble, sheathing-boards laid on these, and the tin roof laid over the sheathing-boards. This solved the problem, and there have been no complaints of the roof since, the tin being in first-class condition after nearly thirty years' service.

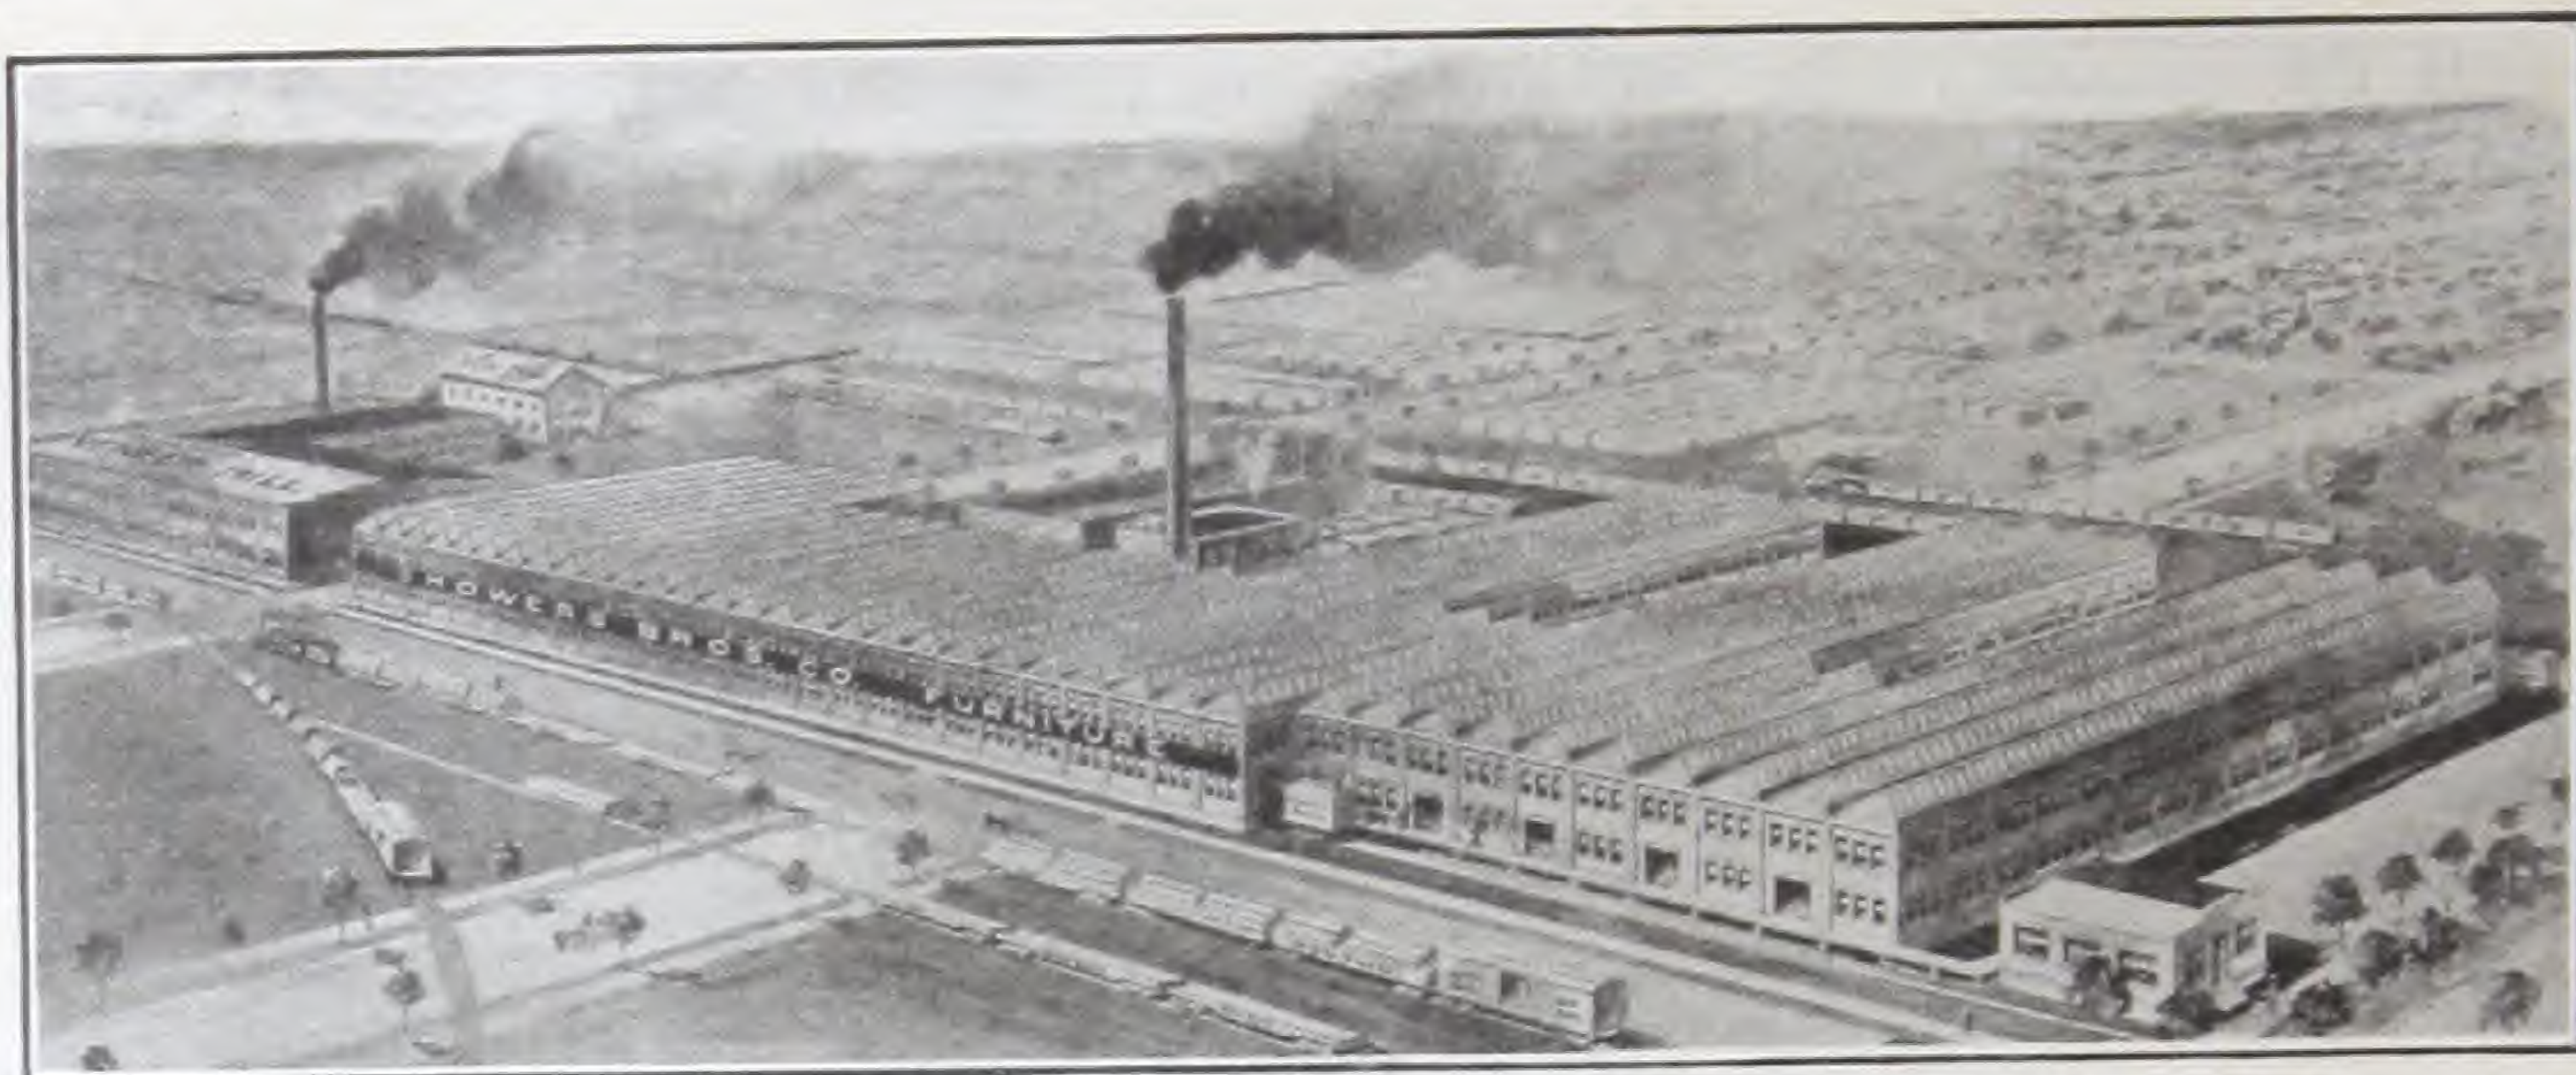
**43. NOTABLE TIN-ROOFING CONTRACTS:** General view of the factory buildings of Showers Brothers Co., furniture manufacturers, at Bloomington, Ind., recently completed. The materials selected for use in these buildings were required to be of the highest quality throughout. Good roofing tin was chosen as the most satisfactory form of roofing that could be obtained at any cost.

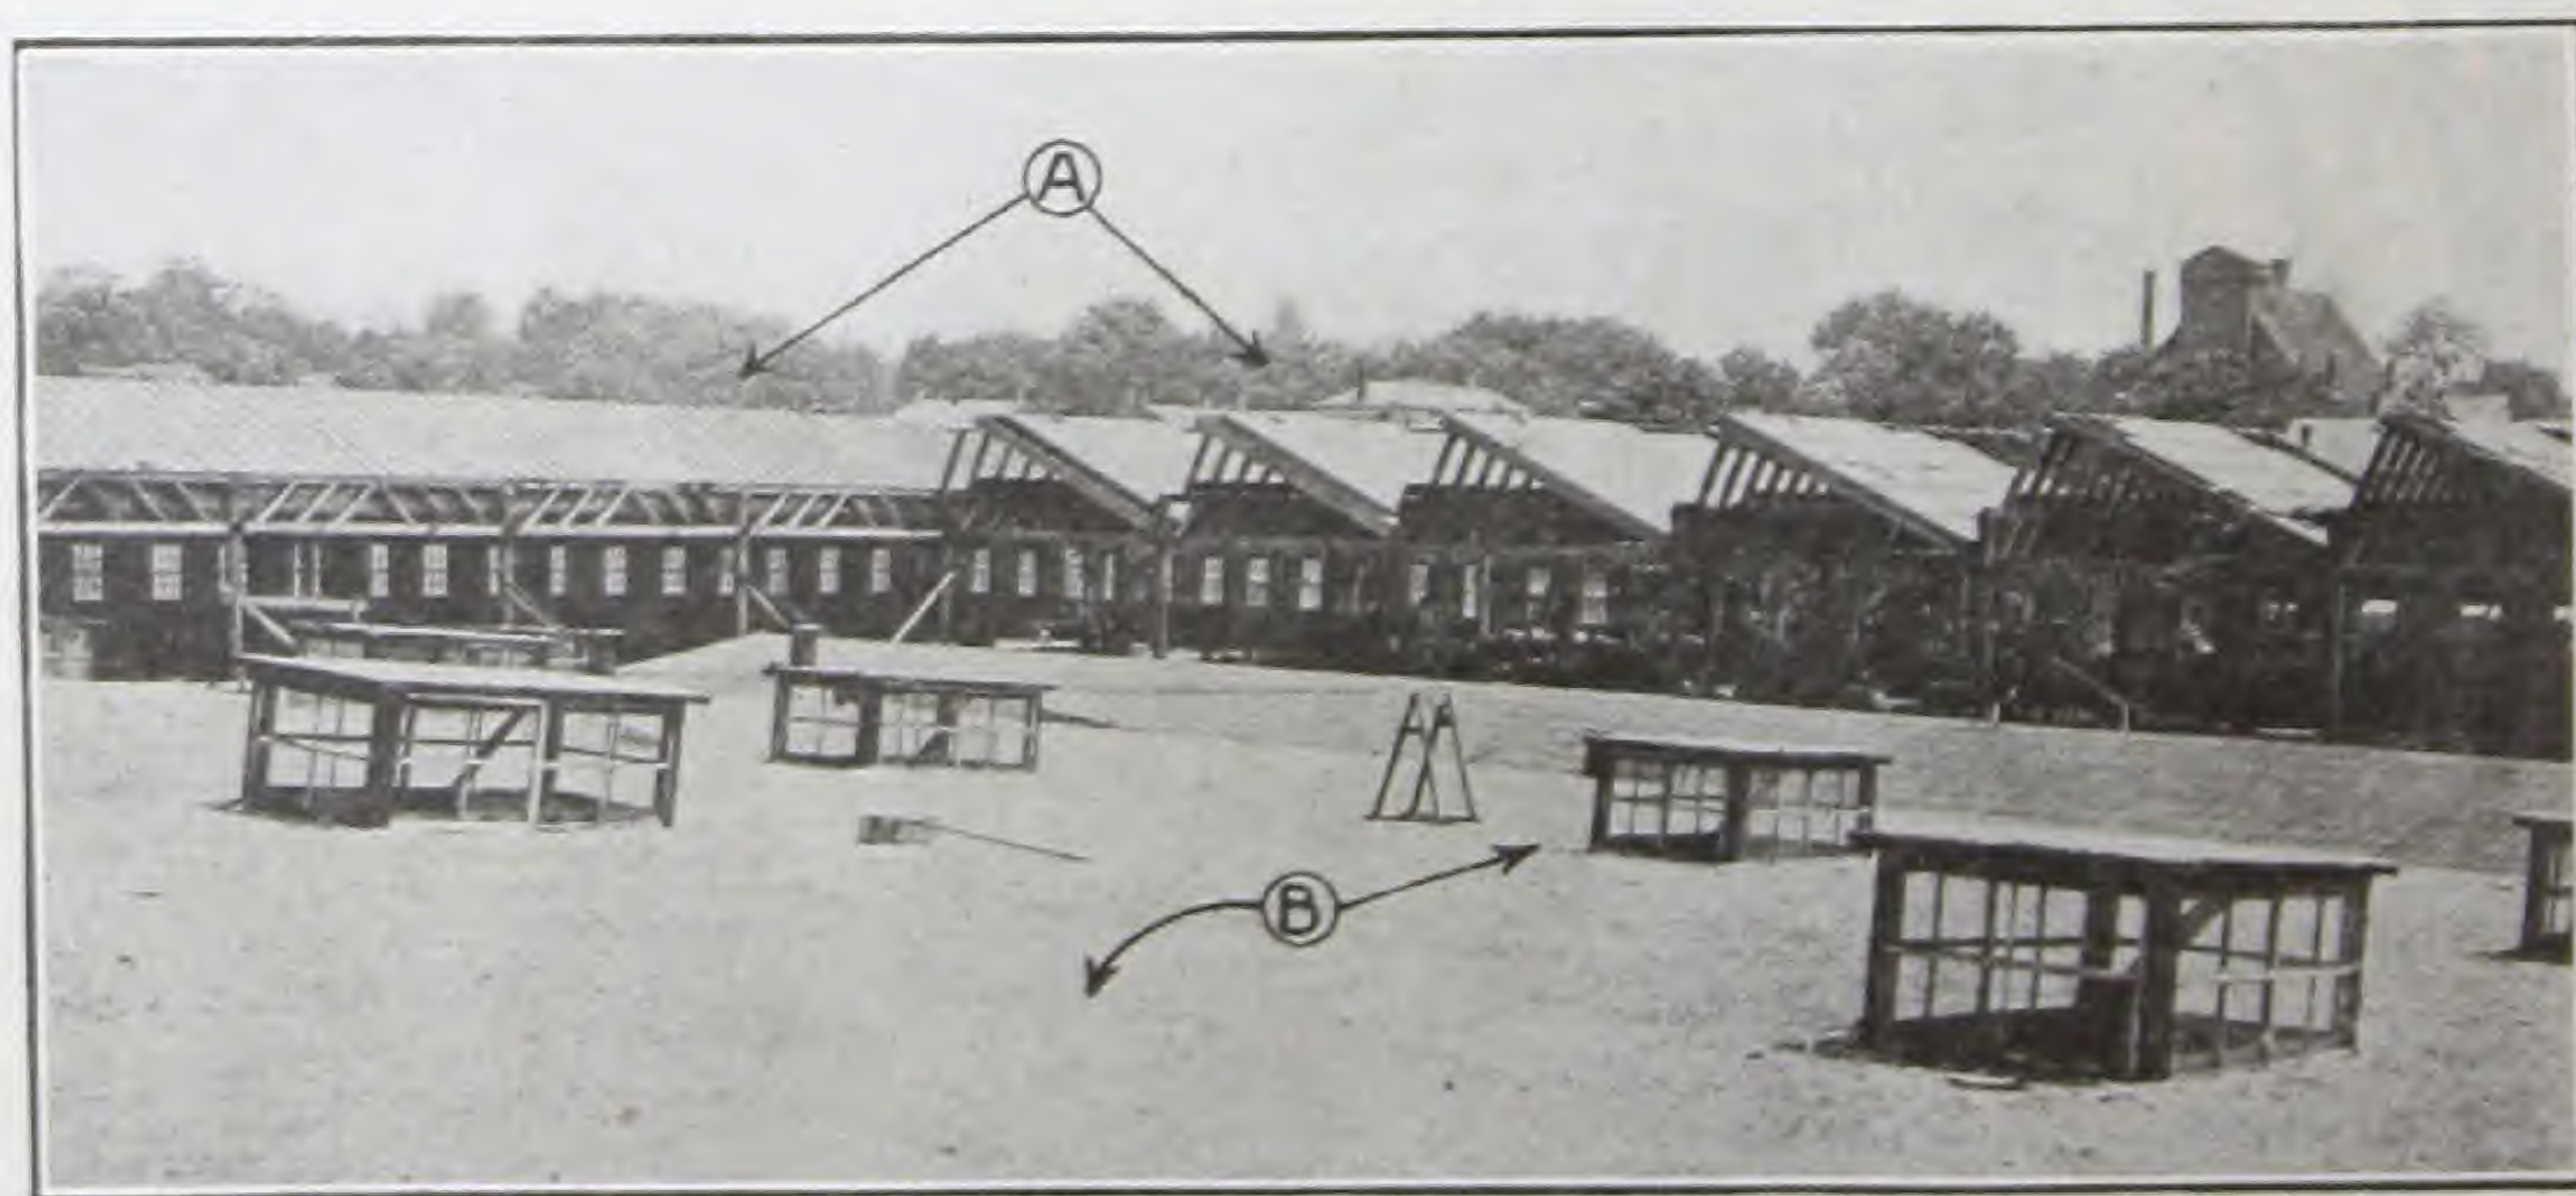
**44. ANOTHER VIEW OF SHOWERS BROTHERS CO. FACTORY, IN COURSE OF CONSTRUCTION:** In the foreground is shown the obsolete form of skylight and composition roofing. In the background, the modern approved type of saw-tooth construction, roofed with good tin laid with standing seams. To keep the gutters free from ice and snow the overhead steam coils for the heating system run directly underneath the bottom pitch of the roof forming the gutter. Here the sheathing-boards are laid  $\frac{1}{4}$ " apart, permitting the tin to be heated from the under side by the radiating coils.
